## Access Oil Tools Proof Load Test Certification

| Report # : NDT17716-TS1105 | | Asset ID : TOOL #797 7" ELEVATOR | |

**Results****Magnetic Particle Examination Conducted On - Elevator - TOOL #797 7" ELEVATOR**

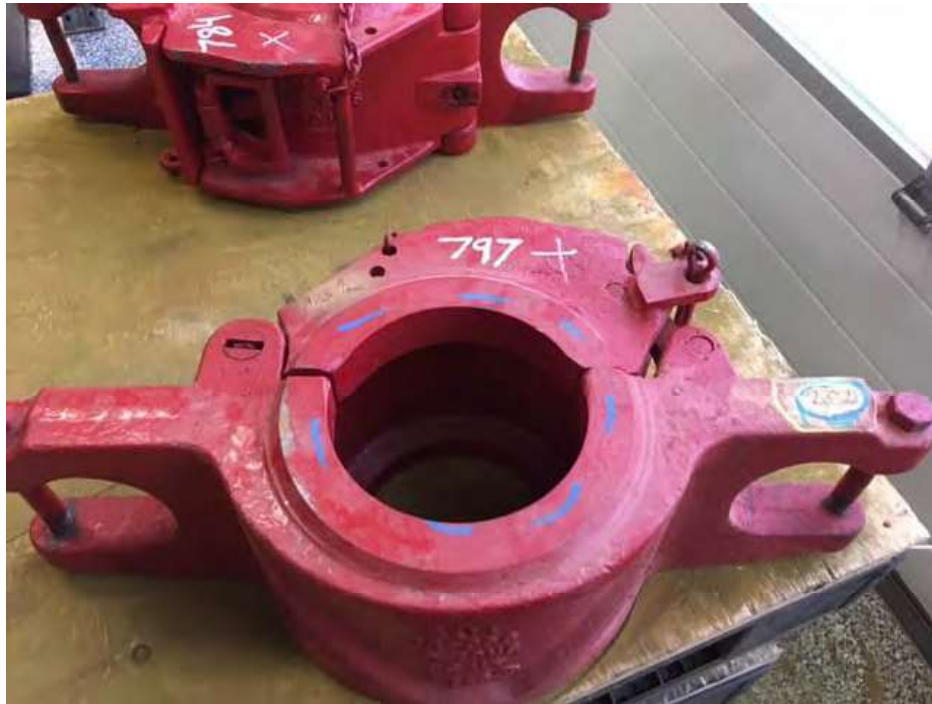
797.jpg

Examination Conducted On 7" Elevator; All Accessible Surfaces, Transition Areas And Lift Points On Fully Assembled Painted Elevator As Requested.

Results: No Relevant Indications Were Detected At The Time Of Examination.

See Photo.
